Arboriculture Impact Assessment

**Lot 4 in DP29244
77 Kulgoa Road, Pymble NSW 2073**

Date: 11 July 2024
Reference: 20242078
Revision: 5

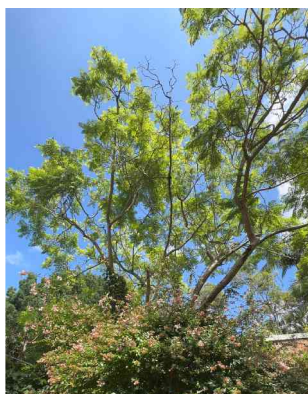
59
Jacaranda mimosifolia
(Jacaranda)

- 10.1.1. Tree No. 59 *Jacaranda mimosifolia* (Jacaranda) is a dominant and young exotic tree located onsite. It is in fair condition with a 'TreeAZ' rating of 'A2', a 40+yrs life expectancy and low in significance. The existing dwelling proposed for demolition encroaches the 4.8m TPZ by a minor 7%.

- Recommendations
 - Demolition machinery to work from hard surfaces only
 - Tree protection fencing required
- 10.1.2. Tree No. 61 *Camellia reticulata* (Reticulata Camellia) is a dominant and mature exotic tree located onsite. It is in fair condition with a 'TreeAZ' rating of 'Z1', a 40+yrs life expectancy and low in significance. The existing dwelling proposed for demolition encroaches the 2.4m TPZ by a minor 6%.

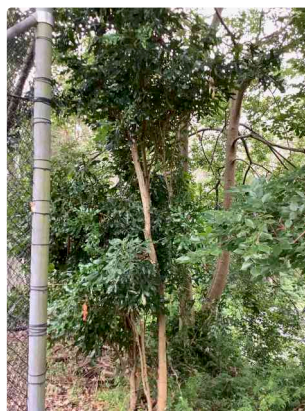
65
Eucalyptus saligna (Sydney
Blue Gum)

- Recommendations
 - Demolition machinery to work from hard surfaces only
 - Tree protection fencing required
- 10.1.3. Tree No. 65 *Eucalyptus saligna* (Sydney Blue Gum) is a codominant and mature indigenous tree located onsite. It is in fair condition with a 'TreeAZ' rating of 'A2', a 40+yrs life expectancy and high in significance. The existing tennis court proposed for demolition encroaches the 12m TPZ by a major 19%.

- Recommendations
 - Demolition machinery to work from hard surfaces only
 - Mulch using composted leaf mulch
 - Apply micro irrigation to TPZ remaining connected to a designated water source

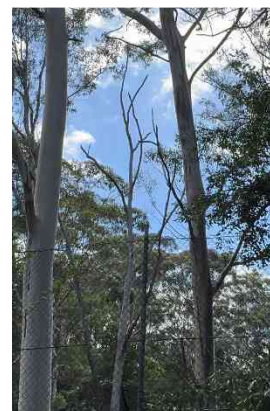
66
Stenocarpus sinuatus (Fire
Wheel Tree)

- Tree protection fencing required
- 10.1.4. Tree No. 66 *Stenocarpus sinuatus* (Fire Wheel Tree) is a dominant and young native tree located onsite. It is in good condition with a 'TreeAZ' rating of 'Z1', a 40+yrs life expectancy and low in significance. The existing tennis court proposed for demolition encroaches the 2.4m TPZ by a minor 6%.

- Recommendations
 - Demolition machinery to work from hard surfaces only
 - Tree protection fencing required

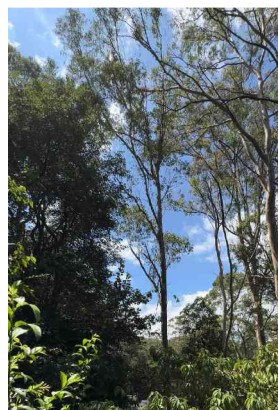
69
Eucalyptus saligna (Sydney
Blue Gum)

10.1.5. Tree No. 69 *Eucalyptus saligna* (Sydney Blue Gum) is a codominant and mature indigenous tree located onsite. It is in fair condition with a 'TreeAZ' rating of 'A2', a 40+yrs life expectancy and high in significance. The existing tennis court proposed for demolition encroaches the 7.2m TPZ by a major 17%.

- Recommendations
 - Demolition machinery to work from hard surfaces only
 - Mulch using composted leaf mulch
 - Apply micro irrigation to TPZ remaining connected to a designated water source
 - Tree protection fencing required

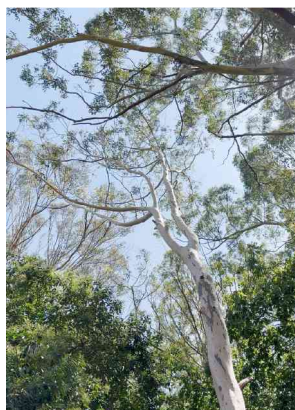
80
Eucalyptus saligna (Sydney
Blue Gum)

10.1.6. Tree No. 80 *Eucalyptus saligna* (Sydney Blue Gum) is a dominant and mature indigenous tree located onsite. It is in fair condition with a 'TreeAZ' rating of 'A2', a 40+yrs life expectancy and high in significance. The existing tennis court proposed for demolition encroaches the 9.6m TPZ by a major 22%.

- Recommendations
 - Demolition machinery to work from hard surfaces only
 - Mulch using composted leaf mulch
 - Apply micro irrigation to TPZ remaining connected to a designated water source
 - Tree protection fencing required

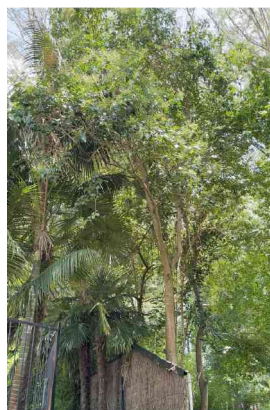
81
Eucalyptus saligna (Sydney
Blue Gum)

10.1.7. Tree No. 81 *Eucalyptus saligna* (Sydney Blue Gum) is a dominant and semi mature indigenous tree located onsite. It is in fair condition with a 'TreeAZ' rating of 'A2', a 40+yrs life expectancy and high in significance. The existing tennis court proposed for demolition encroaches the 4.8m TPZ by a minor 1%.

- Recommendations
 - Demolition machinery to work from hard surfaces only
 - Tree protection fencing required
